A Technical Report on the Recent Floods in District Kangra, Himachal Pradesh

DOCUMENT CONTROL AND DATA SHEET

Report Number	SCSTE/SCCC/Disaster Management
Month & Year	September 2021
Title	A Technical Report on the Recent Floods in District Kangra, Himachal Pradesh
Type of Report	Scientific Report
Authors	Randhawa S.S., Dhar S., Pandey S., Thakur N. and Bharti H.
Originating Unit	State Centre on Climate Change, HP Council for Science Technology & Environment (HIMCOSTE), Vigyan Bhawan, Bemloe, Shimla-1, Himachal Pradesh.
Abstract	<p>Susceptibility of the State of Himachal Pradesh to vagaries of climate change and natural disaster has now been well documented. During the current monsoon season, Kangra District witnessed flash floods after heavy rains on July 11 and 12, 2021. Due to heavy precipitation, the khads originating from the Dhauladhar range flowed with heavy discharge causing enormous damage in the downstream areas of Dharamshala region. The major damage occurred along Manjhi khad, Gaj khad at Shilla, Cheturu and Rajol localities due to toe erosion and channel course change resulting in heavy damage to infrastructure etc. At Boh village of Shahpur Sub Division, a massive la

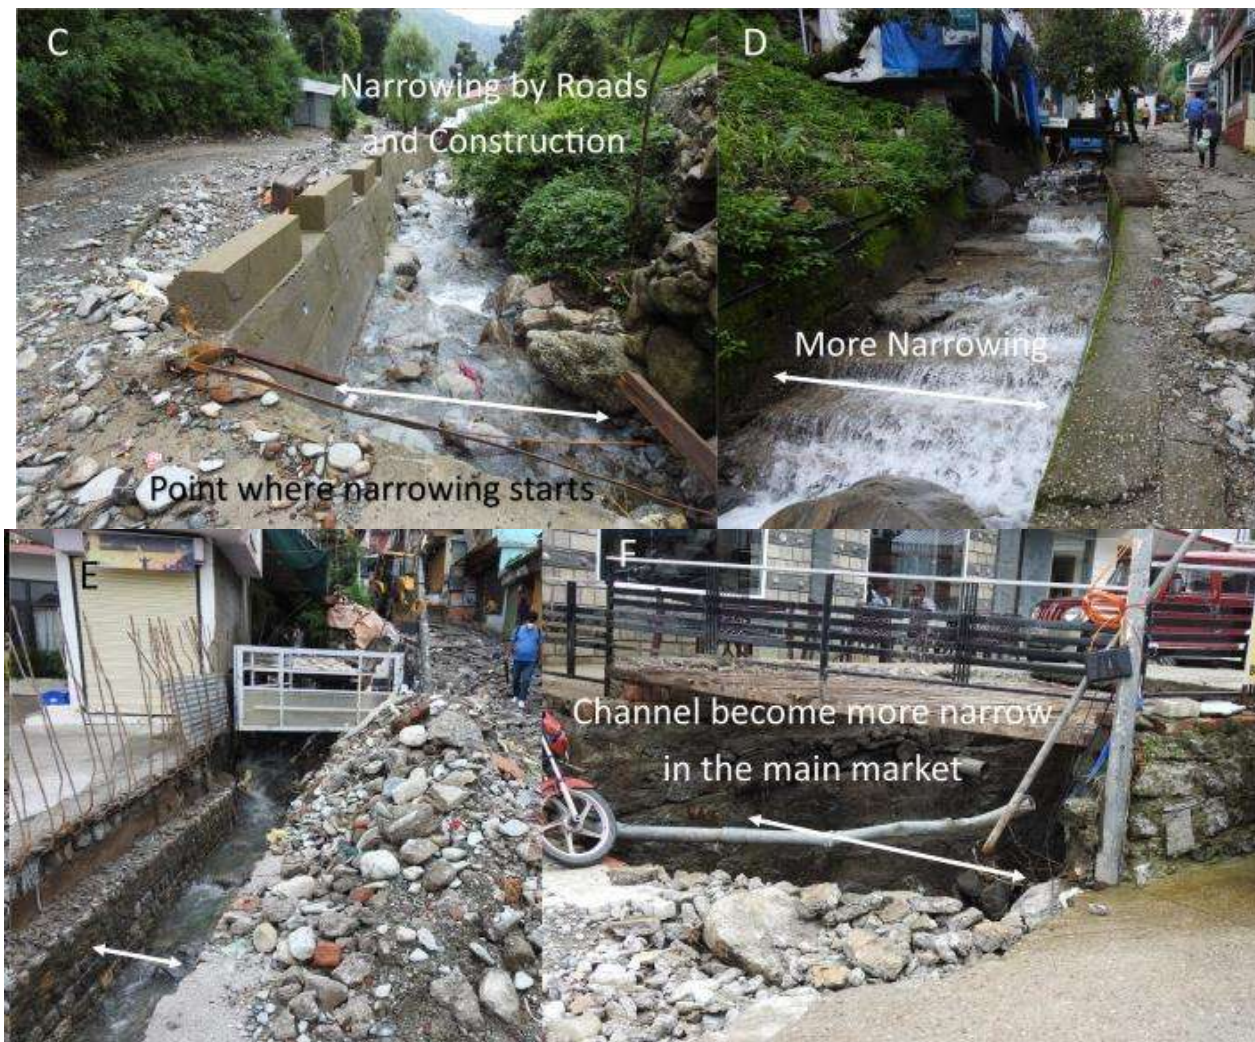
Fig. 6.1: Bhagsunag, Floods (Affected area) in Kangra District, 2021

- At Bhagsunag ($32^{\circ} 14' 37.55''\text{N}$, $76^{\circ} 19' 59.17''\text{E}$), the major damage was occurred mainly due to very heavy flow/ discharge from a seasonal nala which originates from the upper catchment near Dharamkot.

- Based on the field observations, it was found that this is a small nala the original course of which has been obliterated because of the change in the landuse of the area and subsequent conversing of the channel into a pathway in the upper part and the encroachment by the hoteliers in downstream areas.

- Due to heavy downpour on 12th July 2021, a heavy discharge followed by a temporary blockade for some time in the upper catchment near the over bridge and the sudden release of the debris of material stalked because of road cutting work that is taking place on this channel.

- The field observations further reveal that, when the impounded water was released, there would have been a sudden increase in the flow with a very high velocity because of the gradient of the nala.

High annual precipitation, complex lithological attributes and tectonic setting has sculpted the area vulnerable to mass failure. Natural drainage outlets are obliterated by unscientific change of land use. The destruction due to flash floods in Bhagsu Nag area of Dharamsala region is a combination of impairment of natural drainage due to construction activity and encroachment. Slope failure due to the heavy precipitation, hydrological factors such as infiltration, seepage, impoundment and overdose of water coupled with the thick pile of unconsolidated sediment cover has formed an ideal recipe for the slope failure that unleashed havoc in the form of debris flow in the Boh area.

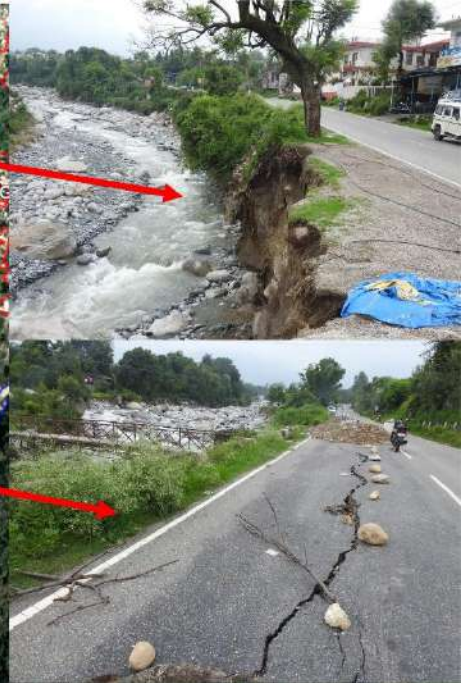
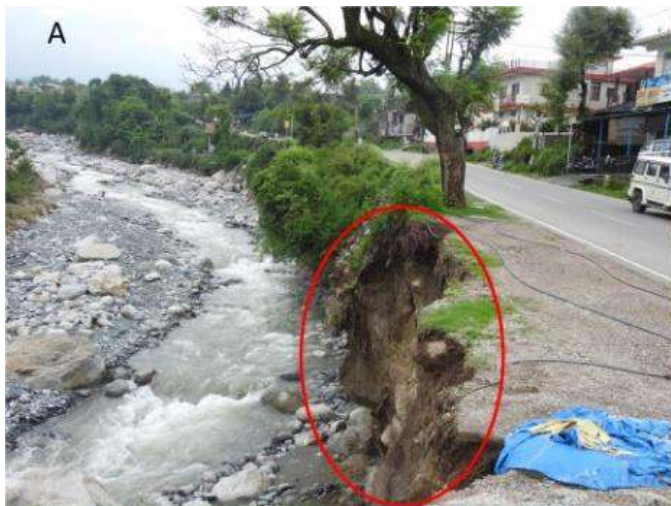
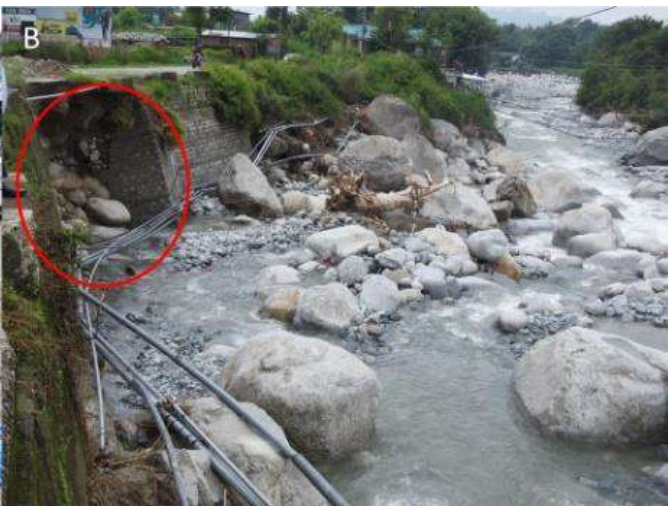
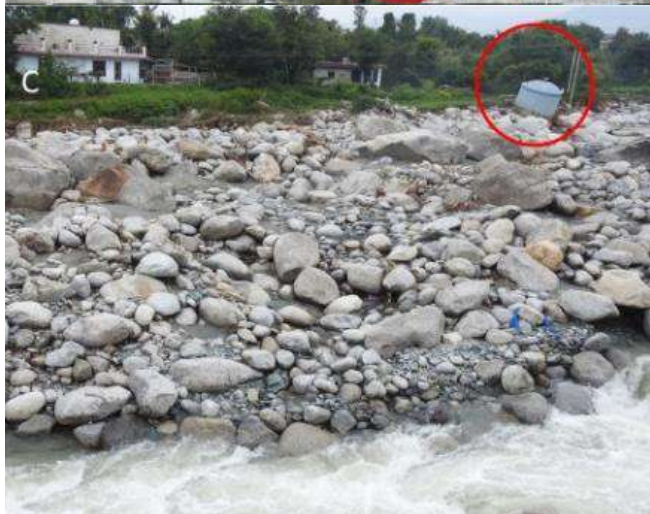
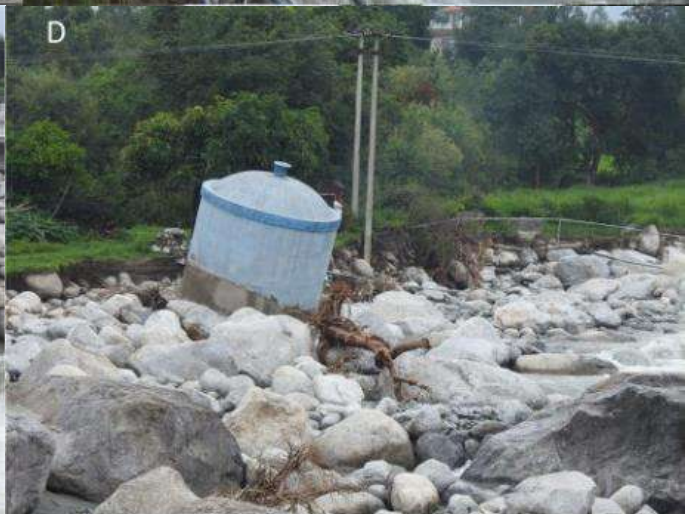
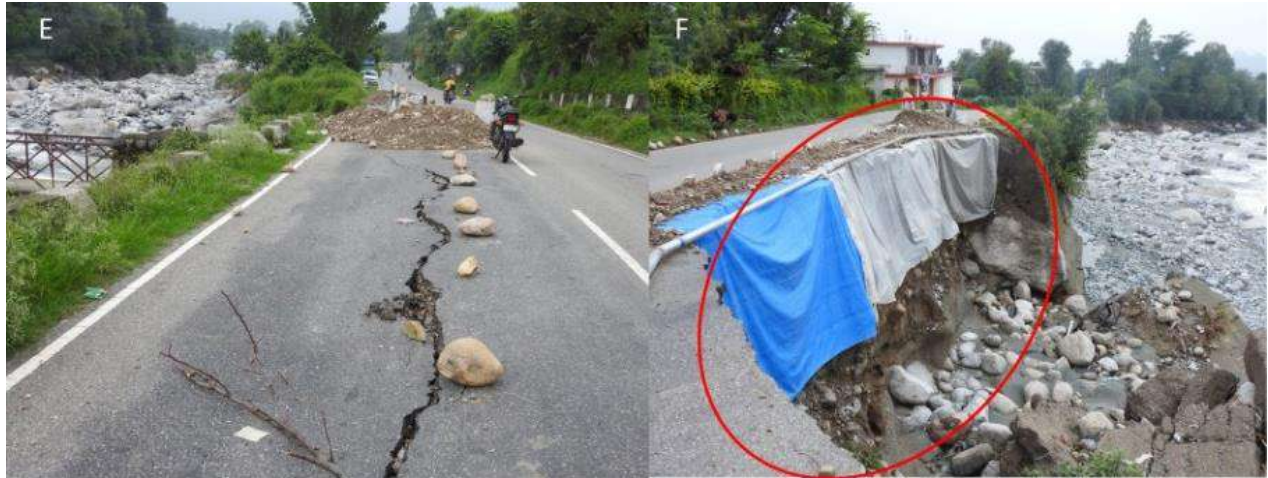
Fig. 6.2 (a): Bhater, Floods (Affected area)in Kangra District, 2021

At Bhater ($32^{\circ}11'28.09''$ N, $76^{\circ}20'19.32''$ E), the Manjhi khad caused heavy damage mainly along the left bank caused due to toe cutting by heavily loaded the over flow (Fig. 6.2 (a)).

Floods and associated devastation in the Manji Khad segment is attributed to the heavy precipitation causing the abnormal flow of water and eroded material in the channel and resulting in the lateral toe erosion of the river terraces regions which are occupied by either constructed area or a road.

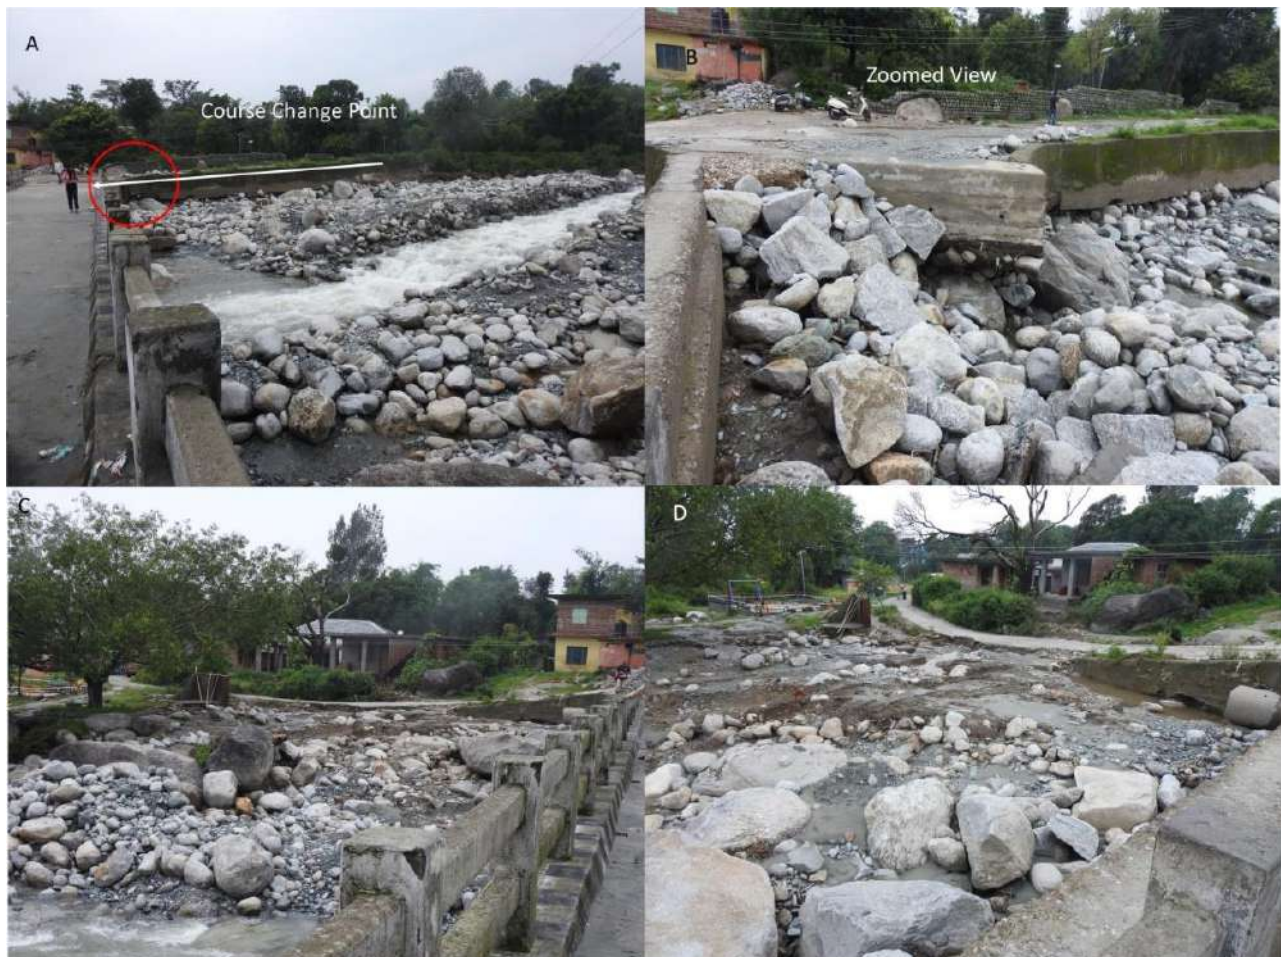
Fig. 6.2(b): Shilla, Floods (Affected area) in Kangra District, 2021

At Shilla ($32^{\circ} 10' 55.86''$ N, $76^{\circ} 19' 34.45''$ E,) again the damage was mainly along the left bank by the heavy discharge and overflow leading to toe erosion and down cutting of the banks and subsequent collapse (Fig.6.2 (b))

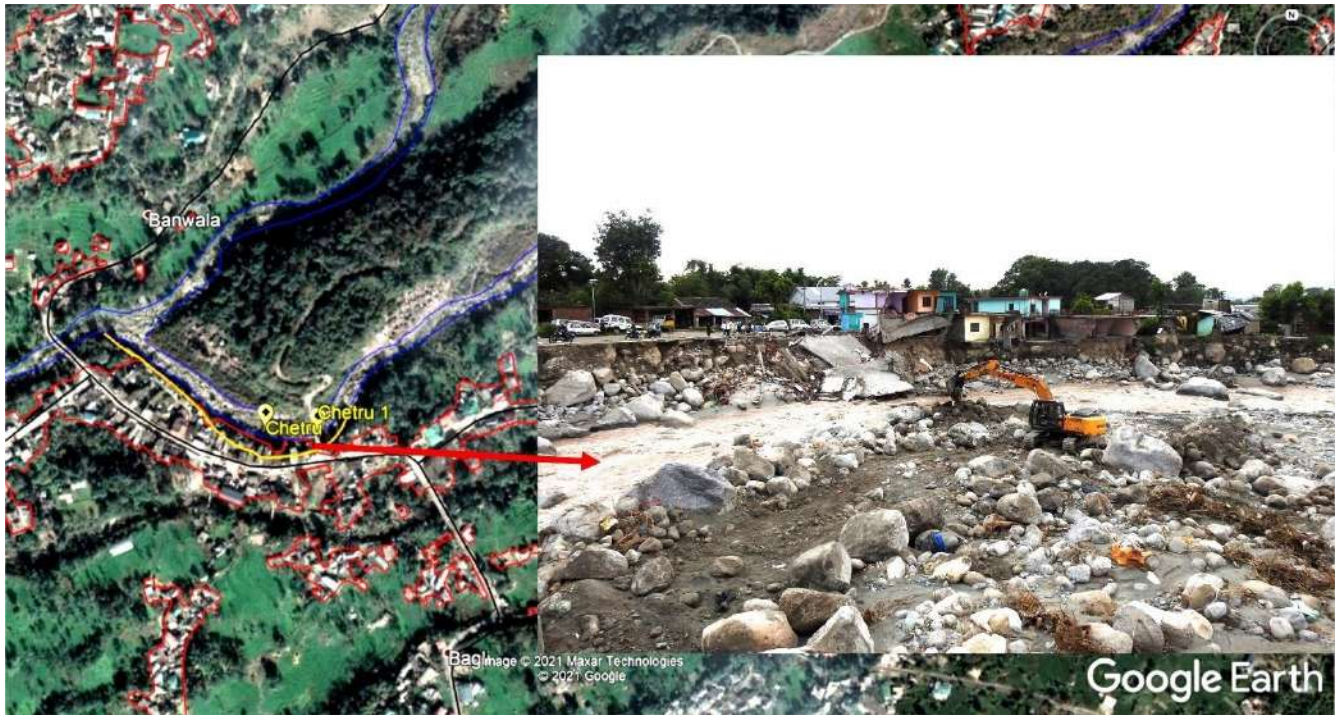
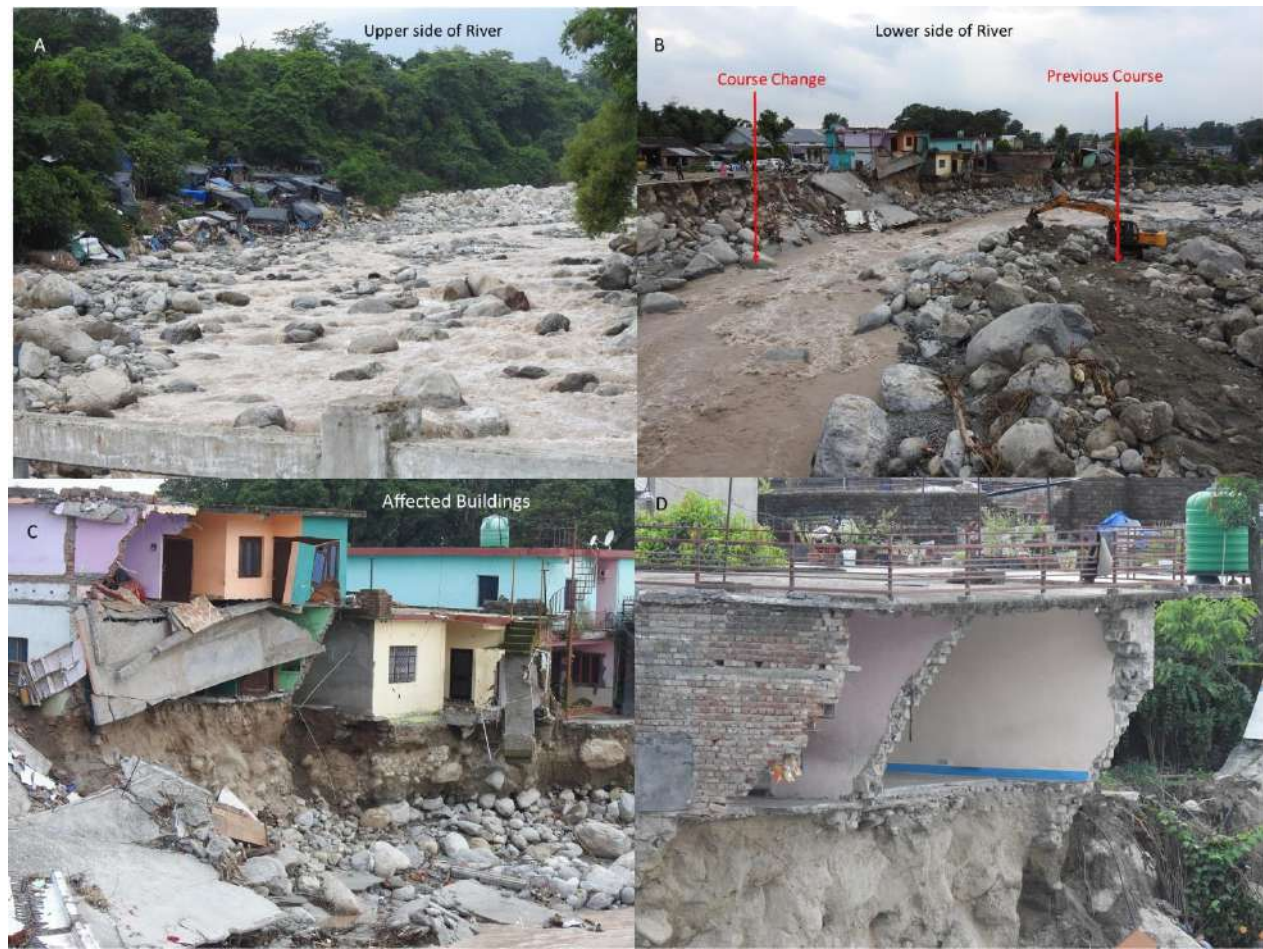
Fig. 6.2(c): Chetru, Floods (Affected area)in Kangra District, 2021

At Chetru ($32^{\circ} 09' 37.77''$ N, $76^{\circ} 17' 38.85''$ E), the major damage was on houses along the left bank of the Manjhi khad to the temporary course change of the flow from right to left side attributed to toe cutting. This resulted in good number of residential houses built on the terrace deposits of the channel be washed away. (Fig.6.2(c)).

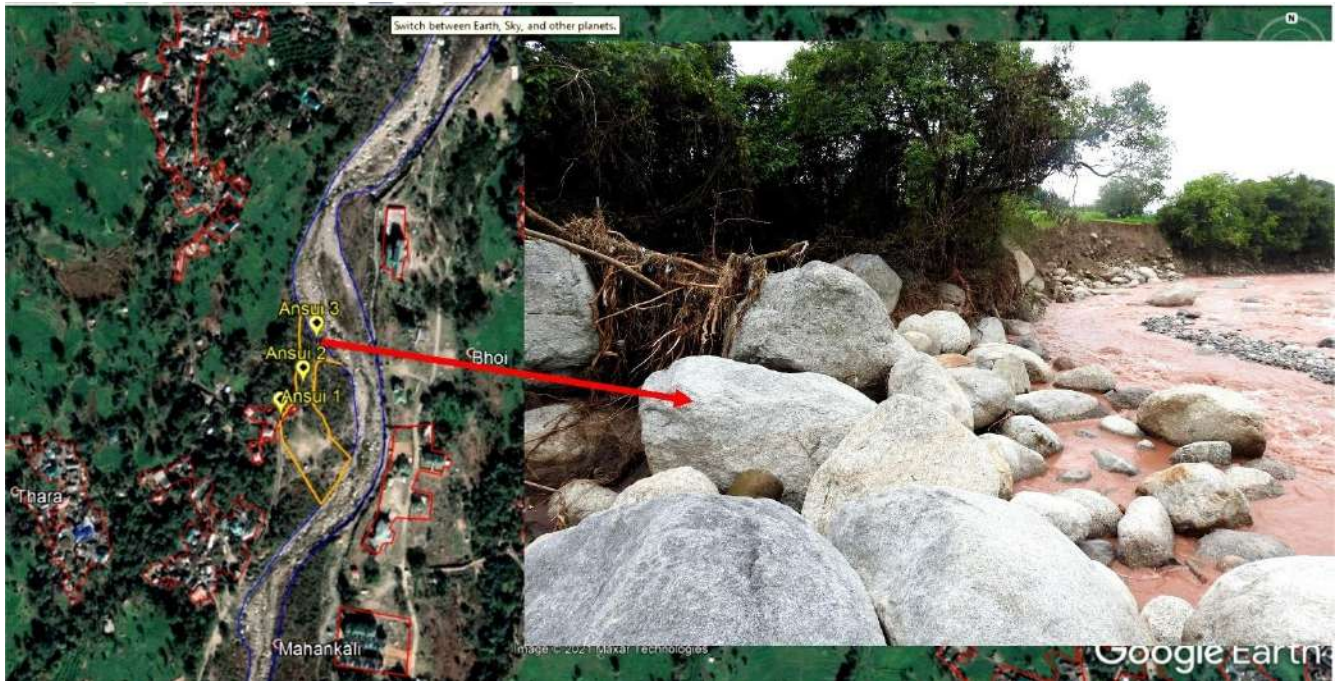
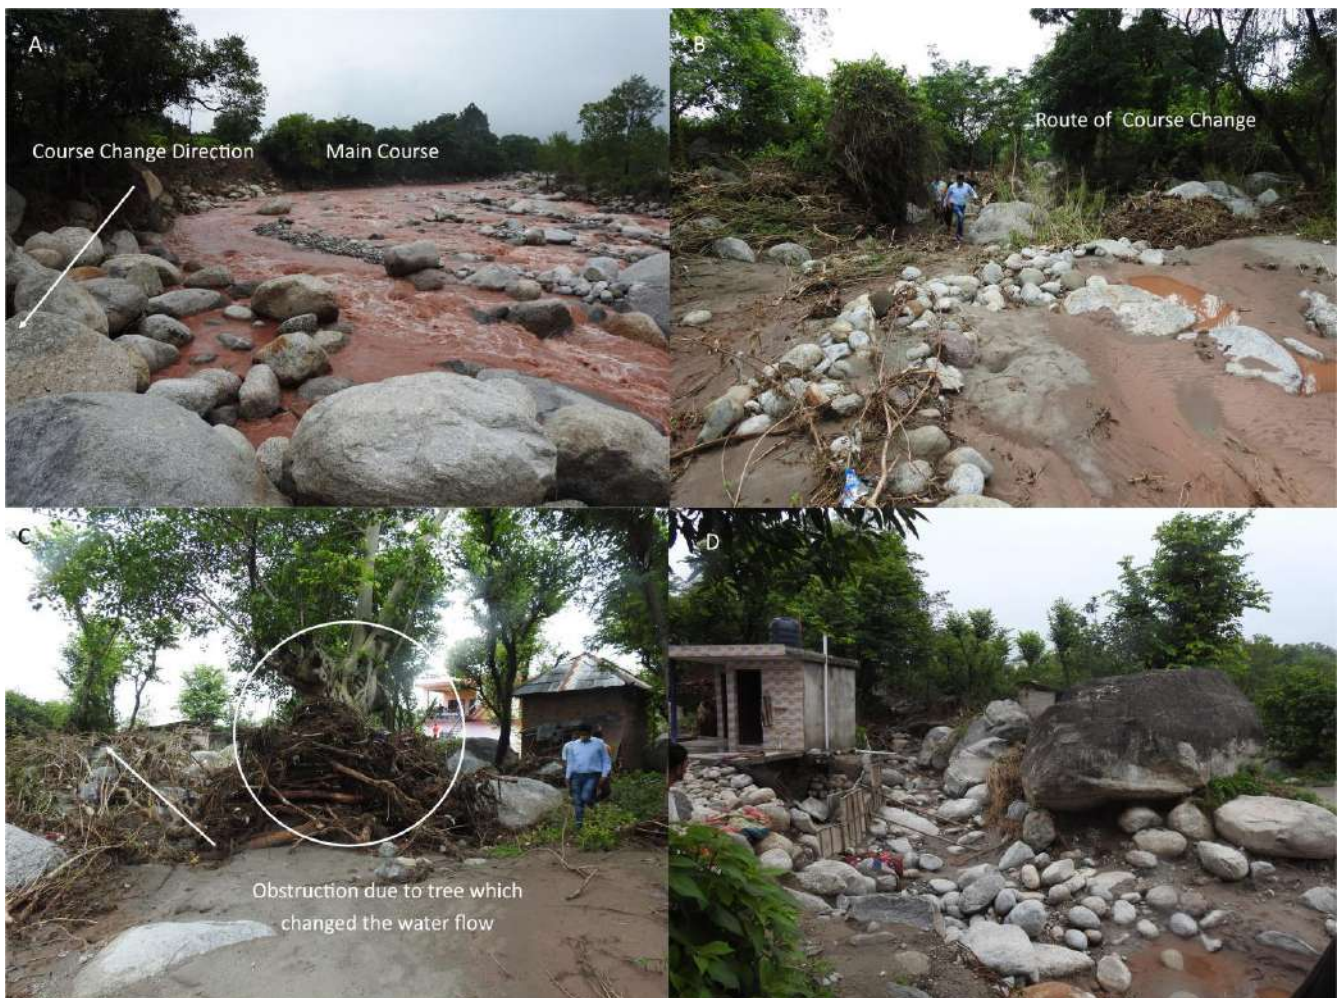
Fig. 6.3(a): Upper Rajol, Floods (Affected area)in Kangra District, 2021

At Upper Rajol ($32^{\circ} 10' 40.66''$ N, $76^{\circ} 15' 0.41''$ E) damage was mainly again on the right bank causing toe cutting and erosion of the agriculture land (Fig .6.3(a)).

Impact of floods in the Gaj Khad segment has mainly resulted due to the temporary course change of the channel and its tendency to follow its old course due to overflow and off shooting of the banks. Under such circumstance when the catchment receives a heavy dose of precipitation the enormous compressed volume of water from the narrow valleys tend to spread out in the region of gentle slopes and wider valley system. In this process the high velocity water heavily loaded with sediments and boulders leaves its present trajectory and tends to flows into its old/Paleo course for some time till the water in the main channel recedes. During the intervening period the disgruntled channel washed away the portion of the Mandi-Pathankot Highway and numerous houses and establishments on the both side of the state highway.

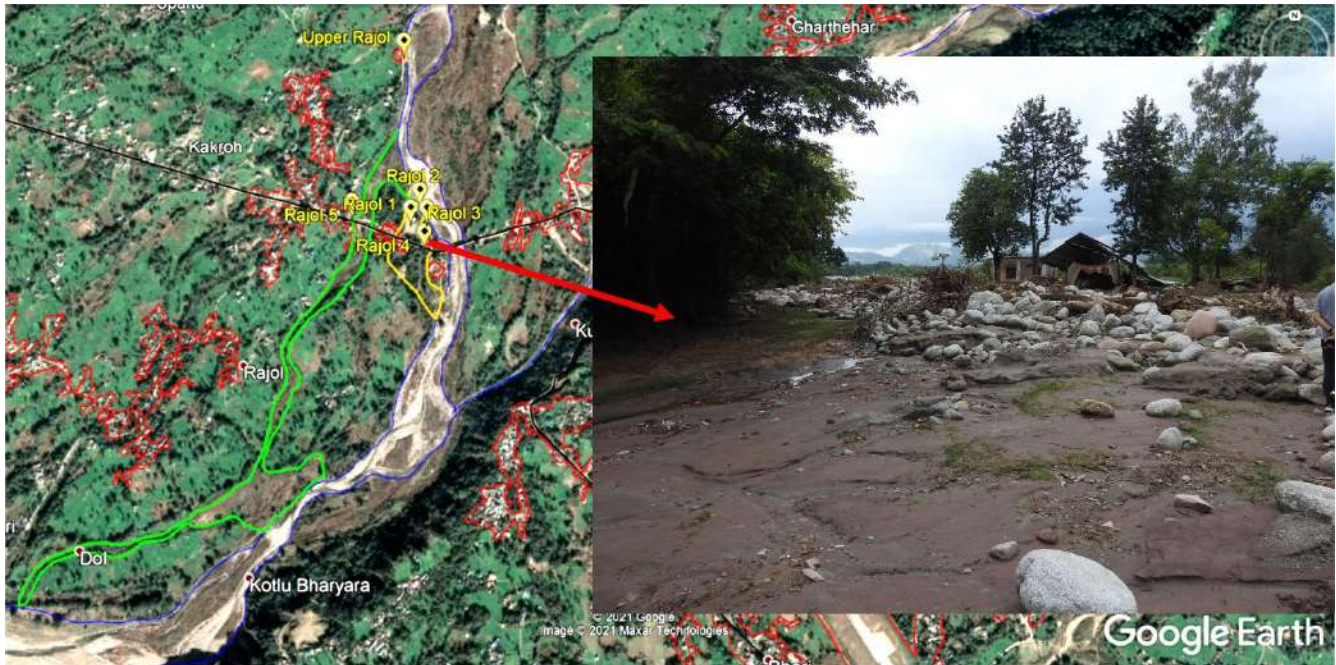
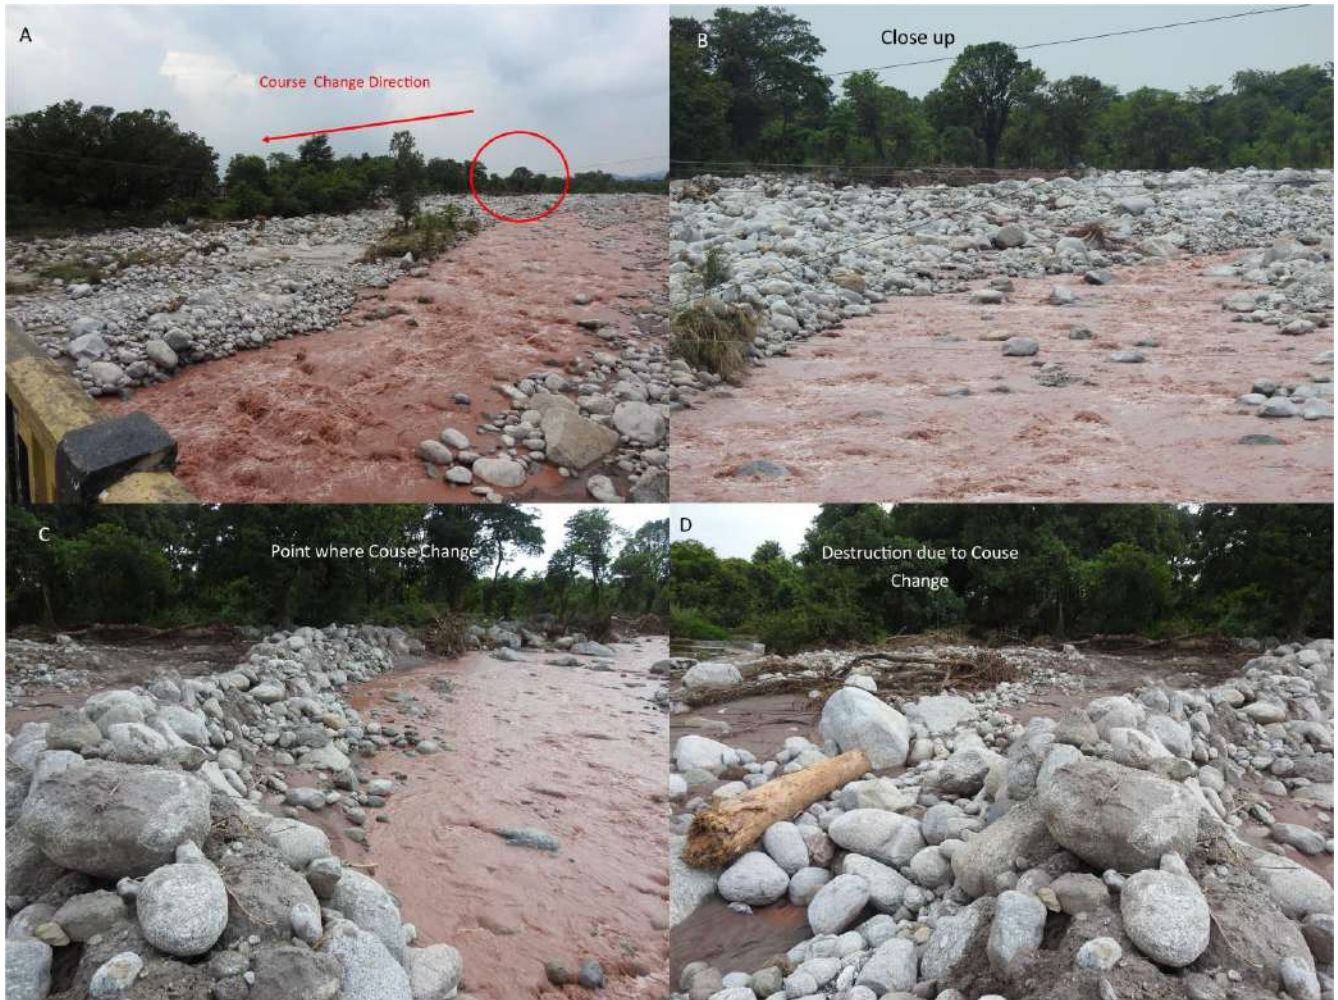
Fig. 6.3(b): Rajol, Floods (Affected area) in Kangra District, 2021

At Rajol on the main National Highway ($32^{\circ} 10' 20.68''$ N, $76^{\circ} 15' 02.32''$ E), the damage observed was mainly due to the change in the river course from the point ($32^{\circ} 09' 37.90''$ N, $76^{\circ} 17' 36.59''$ E,). At this point from the right bank, the river has diverted towards right side leaving the main course and damaged the entire area which including a playground, and other infrastructure and after crossing through the highway the diverted overflow has caused heavy damage to the houses coming under the fury of the turbulent wayward waters of the Khad. (Fig. 6.3 (b) &(c)).

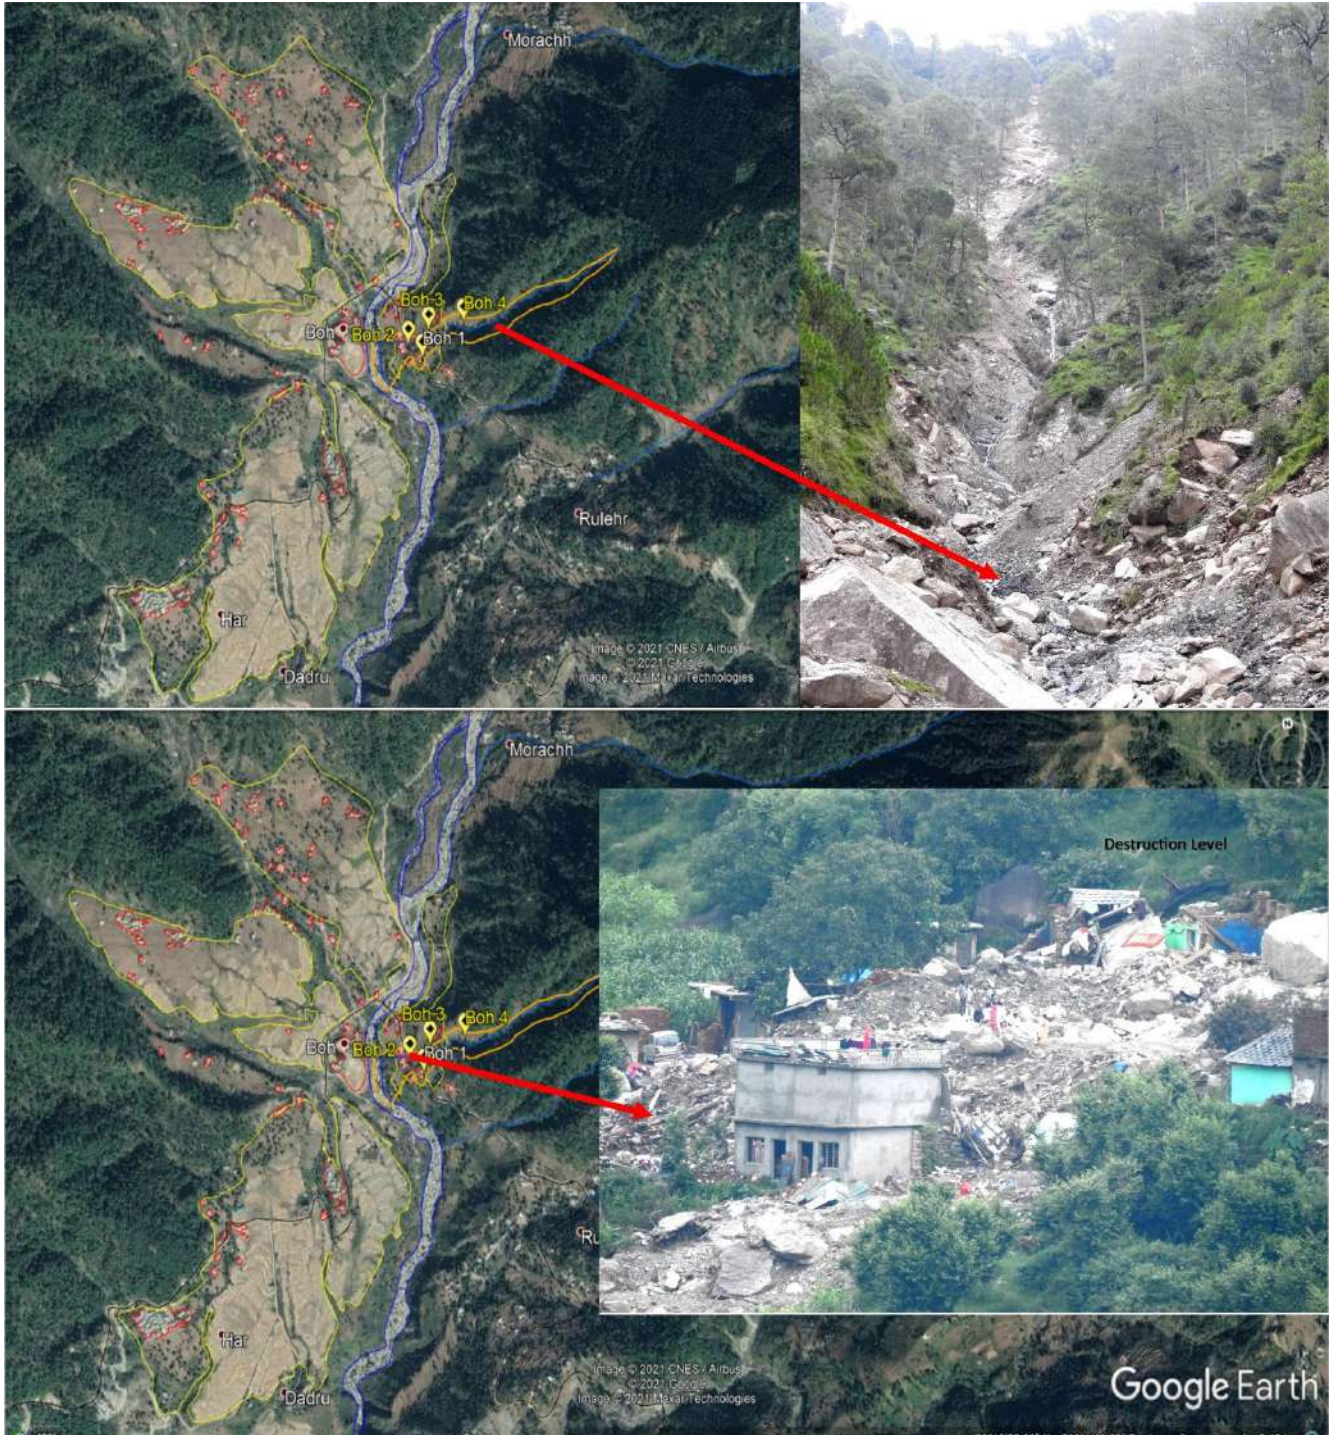
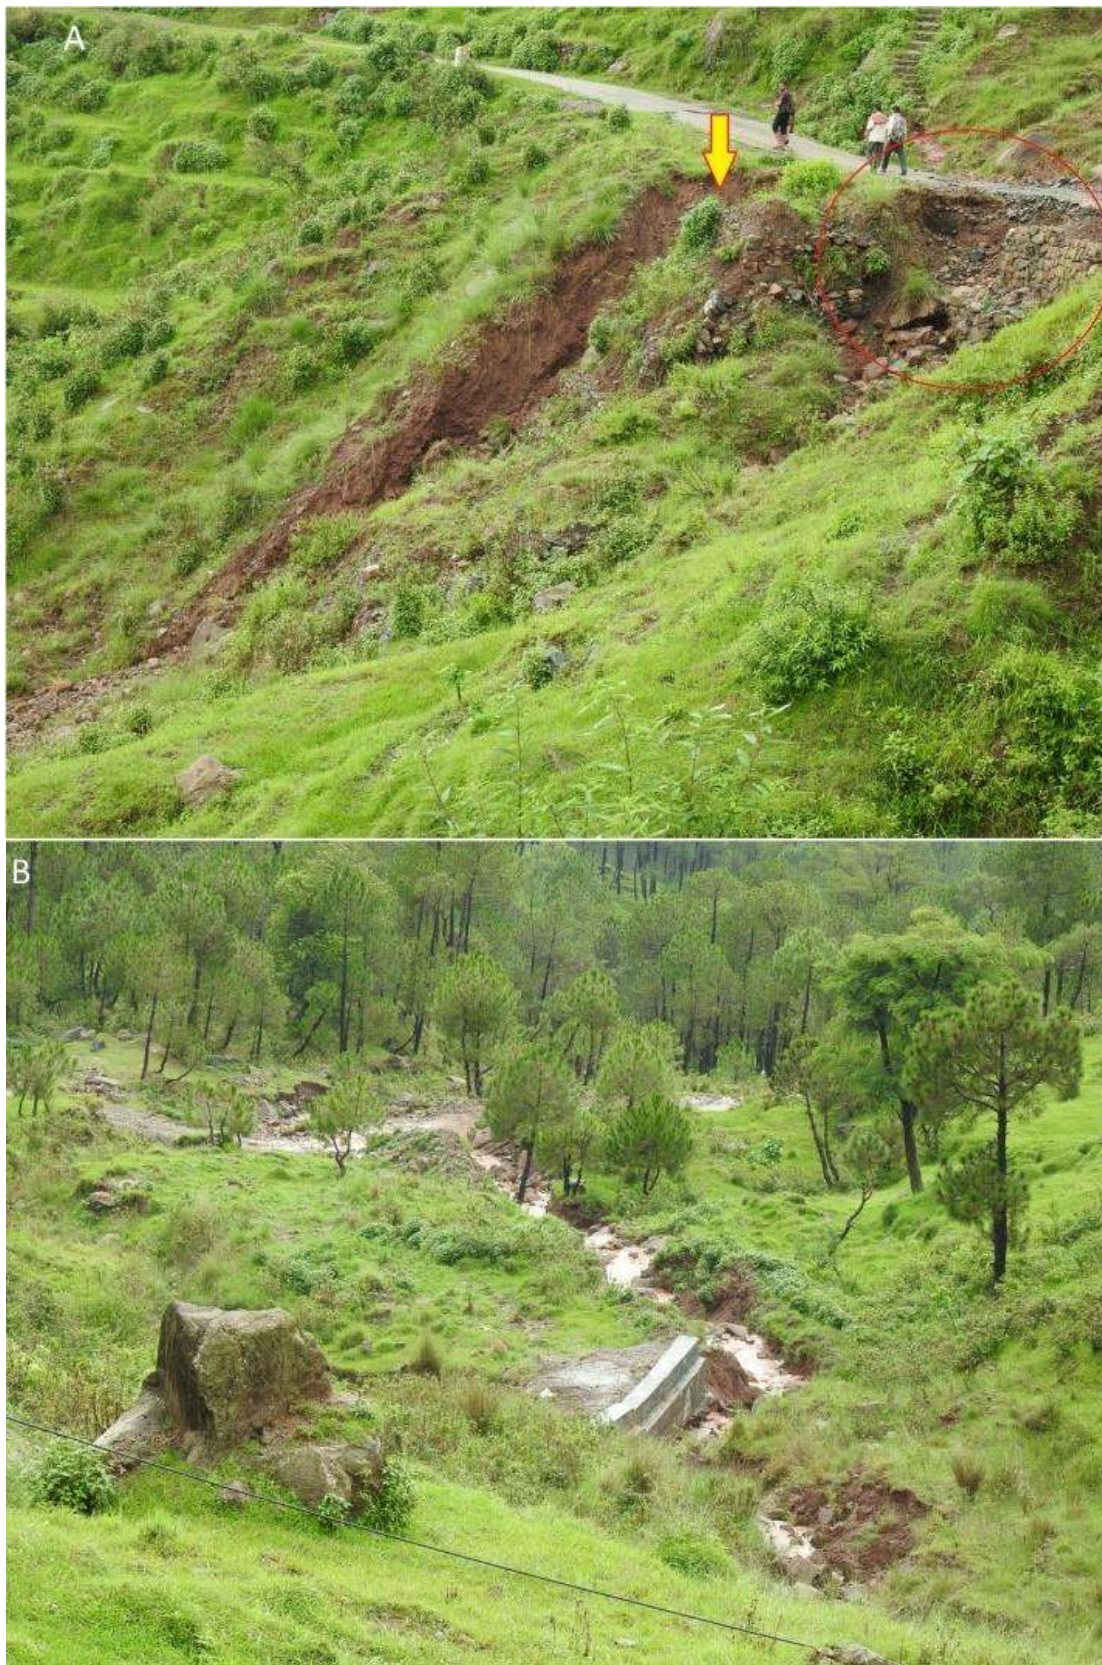
Fig. 6.4(a): Boh, Floods (Affected area) in Kangra District, 2021

On travelling further westwards towards Shahpur on the Mandi –Pathankot National Highway and then towards north on Shahpur-Drini-Boh state road, a massive landslide occurred on the 12th July 2021 killing 10 people, 5 injured and damaging 11 houses. The total damage estimated by the DDMA Kangra District was to the tune of about Rs13.50 Crores. This event has been the most gruesome as along with the property, precious lives were lost due to the horrific activity of debris flow that took place due to heavy downpour.

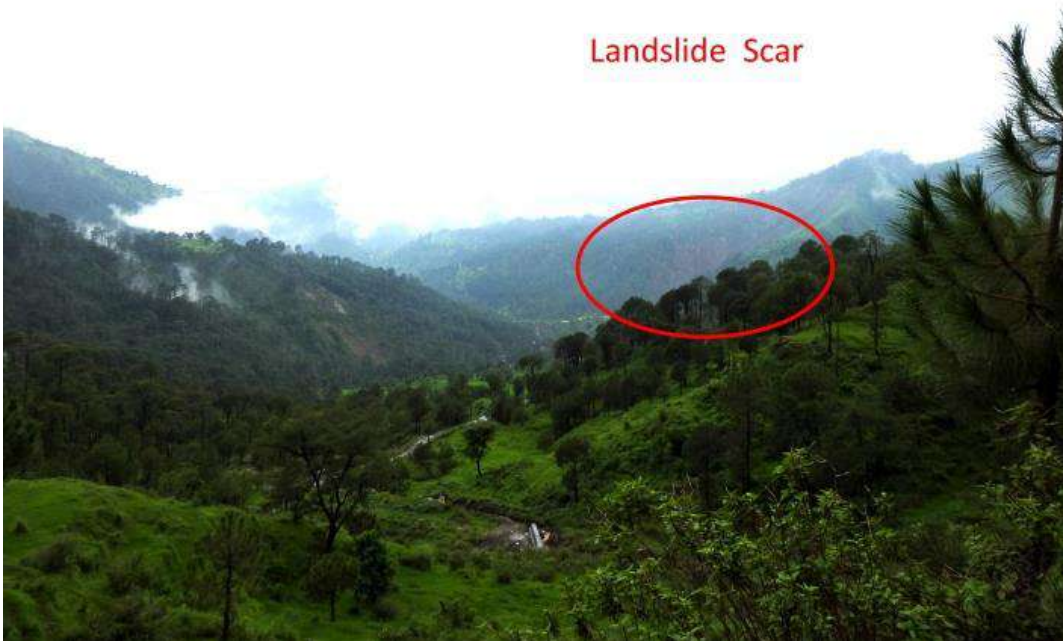
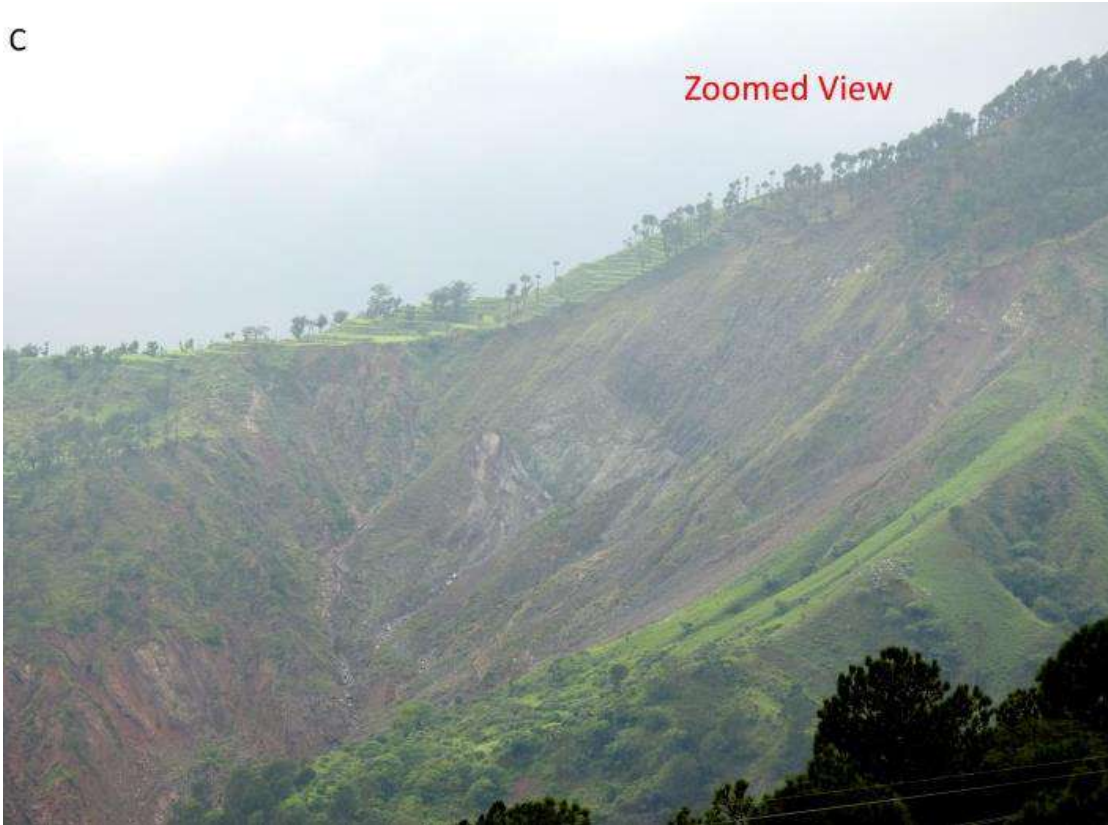
Fig. 6.4(b): Boh, Floods (Affected area) in Kangra District, 2021

Landslide Scar

Zoomed View

Close up

The village Boh is situated ($32^{\circ} 18' 39.50''$ N, $76^{\circ} 11' 18.21''$ E) on the left bank of the Brahl khad which is one of the major tributary of the Dehar khad that culminates in the Pong Dam, further southwards. The landslide affected area of the village is within a small micro watershed having a total area of about 0.16 Sq. Km. Geomorphologically the Boh village is situated within the unconsolidated alluvial sediments comprising sand, gravel, boulders eroded from the upper catchments of the Dhauladhar granites and the Kullu group. The alluvial is mainly confined along either banks of the Brahl khad, whereas the upper catchments show the presence of the denudation hills supported by the rocks of the Kullu Group and the Dhauladhar Granite. Geologically the upper catchment in the region is characterised by the rocks of Kullu Group mainly the phyllites, schist etc. and the unconsolidated alluvial sediments along the Brahl khad and the Boh village.

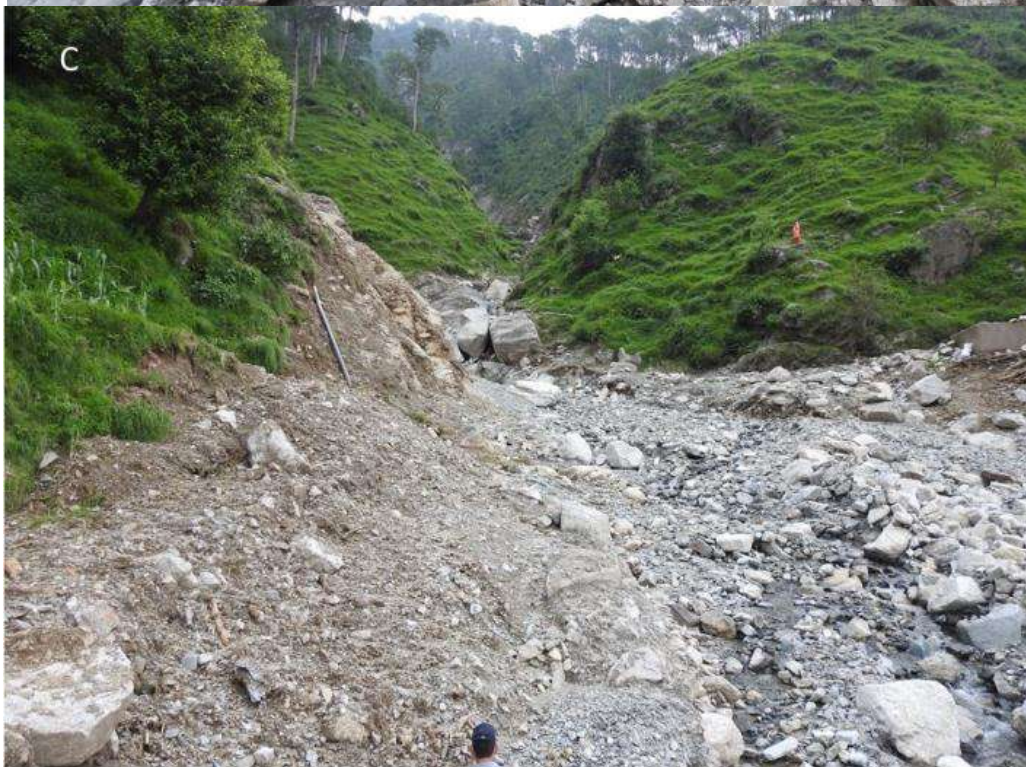
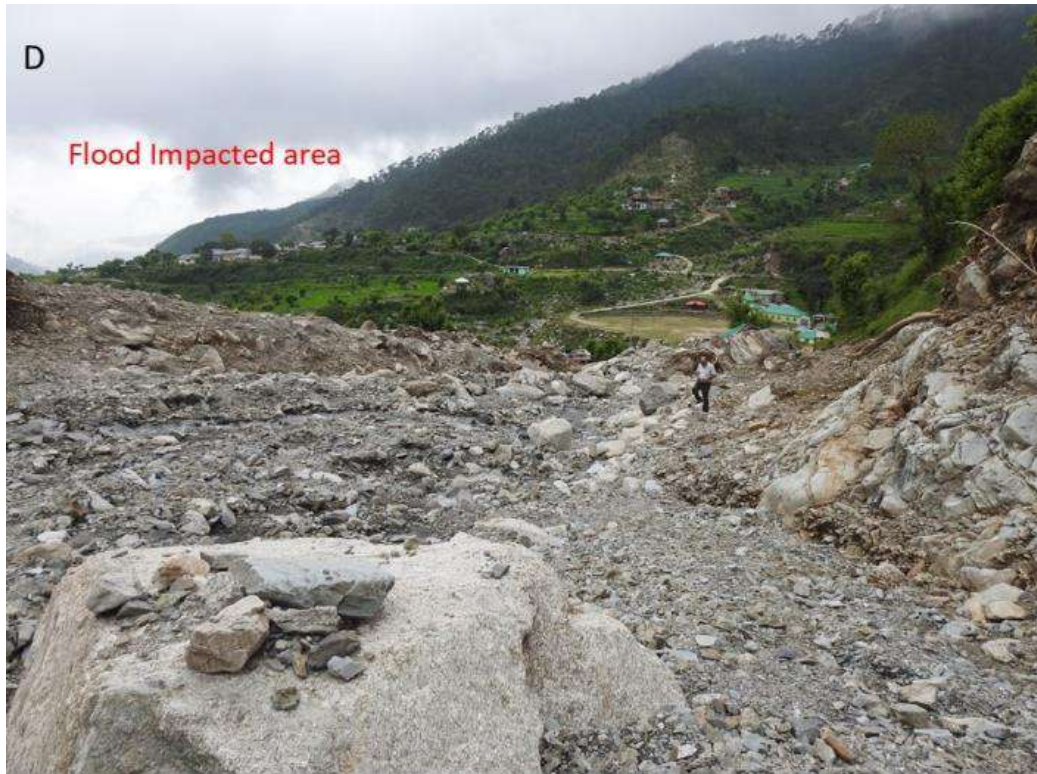
Fig. 6.4(d): Boh, Floods (Affected area) in Kangra District, 2021

The landslide that occurred on 12th July 2021 between 10.30- 11.00AM originated mainly from the over burden of metamorphites which is the in situ rock visible now in the scar area of the landslide. Along with the landslide, overburden of huge erratic granitic boulders of Dhauladhar Granites were washed away due to the heavy rains causing heavy damage in the cluster of houses situated on both flanks of the road connecting the Boh village situated on gentle hill slope which supports a thick veneer of unconsolidated material. In the scar zone, the main reason of the landslide seems to be the detachment of rock mass along with the overburden comprising loose and unconsolidated material of Dhauladhar Granite developed along the weak zone that must have detached along the failure plane between the in situ country rock and the thick blanket of unconsolidated material. The debris flow comprising the detached overburden material and the erratic got impounded in the narrow upstream region and the heavy quantum of rains must have forced a sudden release of the debris and large erratic load along with high velocity causing devastation of the houses on the both side of the Boh road as it buckled down along the slope bulldozing the habitats of the unaware residents.
