**A Technical Report**  
**on**  
**The Lake formation along Biling Lungpa, Lahaul & Spiti**  
**District Himachal Pradesh**

**Submitted to**  
**Department of Revenue, Government of Himachal Pradesh**

**State Centre on Climate Change**  
**(H.P State Council for Science Technology & Environment)**  
**Block-34, SDA Complex, Kasumpti, Shimla-9**

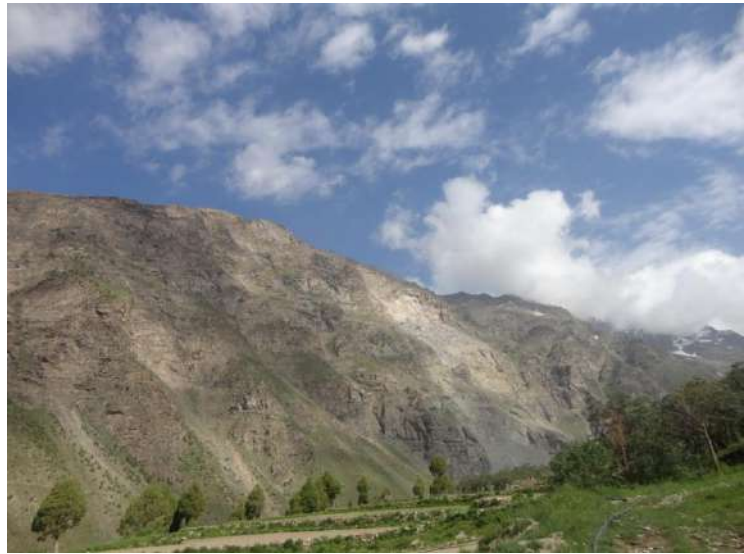
- The affected area is along the right bank of Biling Lungpa which is about 2km from the road head of Tandi-Keylong State Highway.

- Biling Lungpa is one of the major tributary of the Bhaga River and joins it on its right bank at an elevation of 2960mts above msl and the highest point in this basin is at 6045mts above msl. This tributary is being fed by about 19 small and big glaciers along with Gangstand Glacier as one of the largest glacier which feeds the Biling Lungpa.

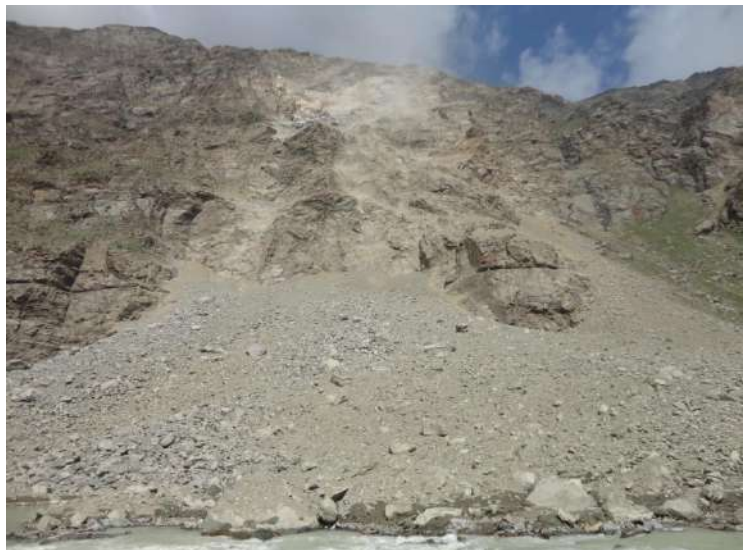
- At an elevation of 3324 mts. and at 32°35.51North latitude and 77°00.75 East longitude, the temporary lake has been formed due to the blockade of the present river course in the early hours of 3<sup>rd</sup> June2014 at around 9AM.

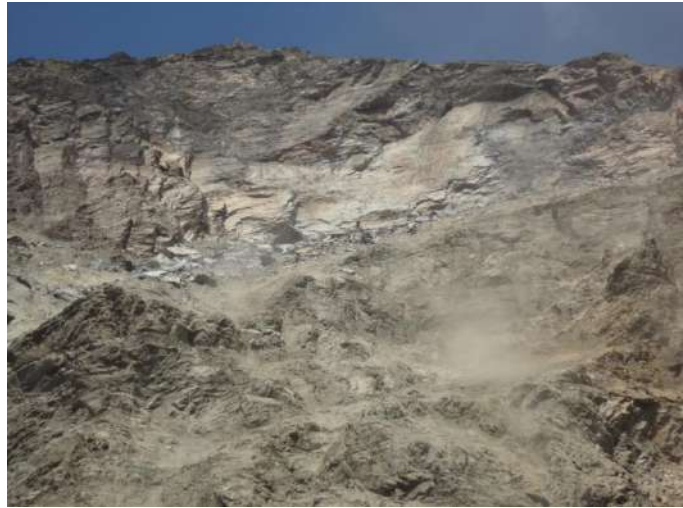
- The main cause for the blockade of the river course is the failure along the cleavage plane of quartzitic bed resulting into breaking huge rock mass and slopping down up to the river level causing a complete blockade of the present course.

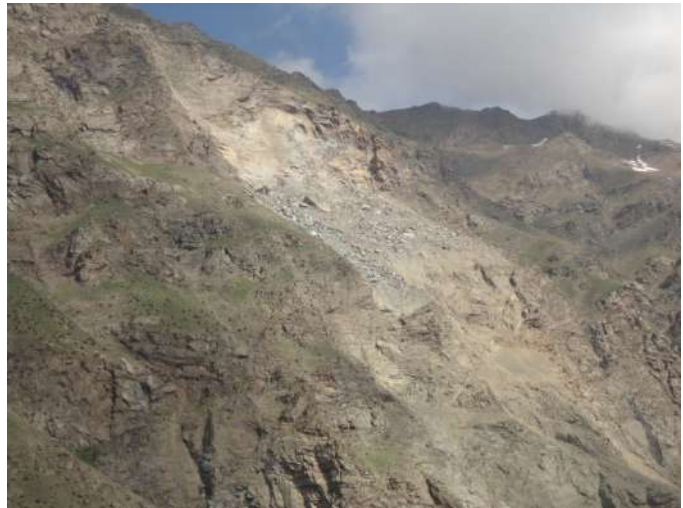
- The rock fall has started from an elevation of about 4400 mts. above msl where the trend of the quartzite beds is almost vertical in nature and have been deposited along the Biling Lungpa.

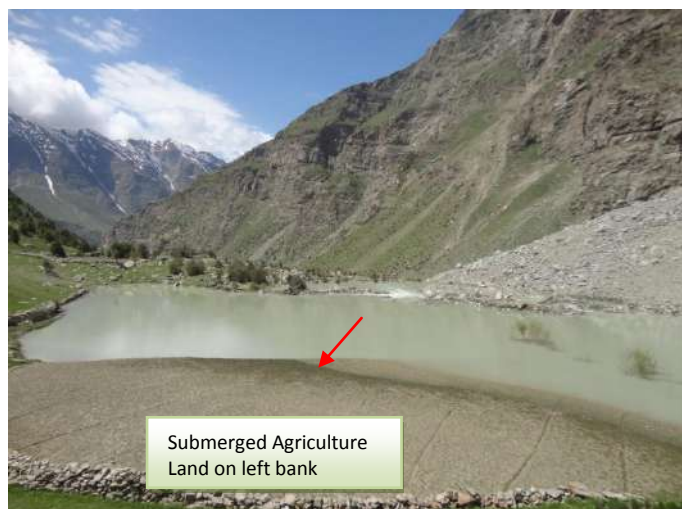
- Due to the chocking of the river course, the water started accumulating backwards with the result the present land cover available the left bank of the Lungpa was submerged in the water.

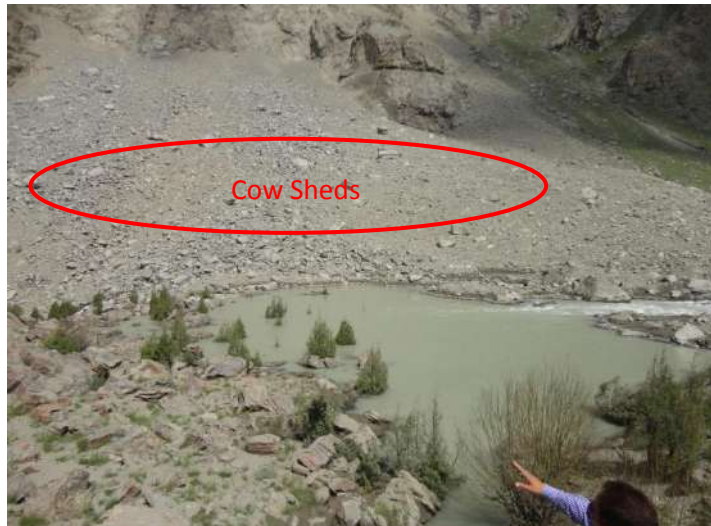
- The sliding rock mass has also eroded the agriculture land and two cowsheds which were previously located along the terraces in the same direction as the remaining fields adjoining to the rock mass on the right bank of the Lungpa.

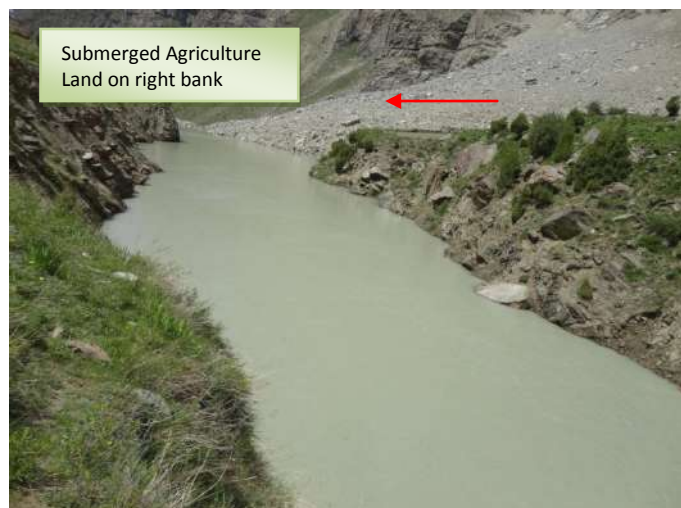
- The rock mass blocked the present river course thereafter the water started accumulating up to the footbridge level in the upstream side up to 32° 35.67North latitude and 77° 00.79 East longitude at an elevation of 3331 mts. above msl.

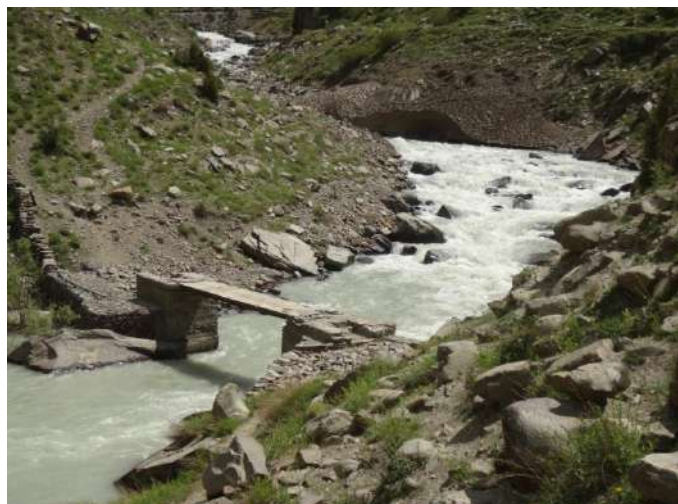
- Thereafter the local villagers cleared the shifted course of the river on the right side of the previous course and also to some extent they cleared the previous course so that the outflow of the accumulated water could be normalised.

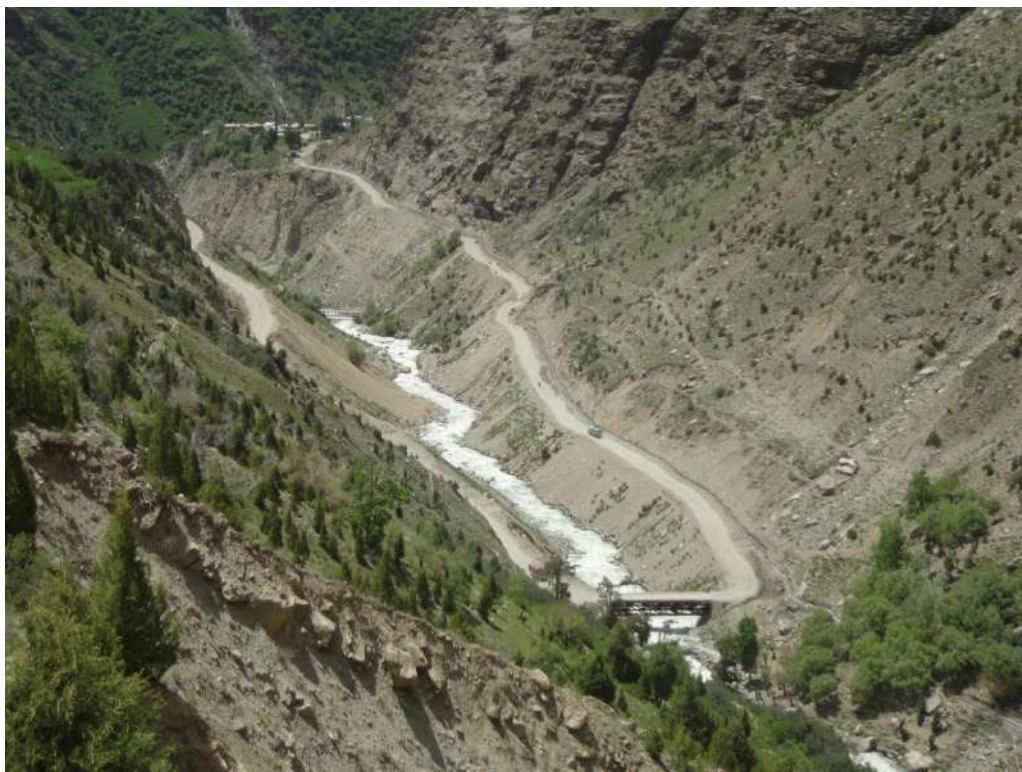
- The downstream area of the Biling Lungpa seems to be more vulnerable to toe erosion as the glaciaded material is more pronounced in these areas.

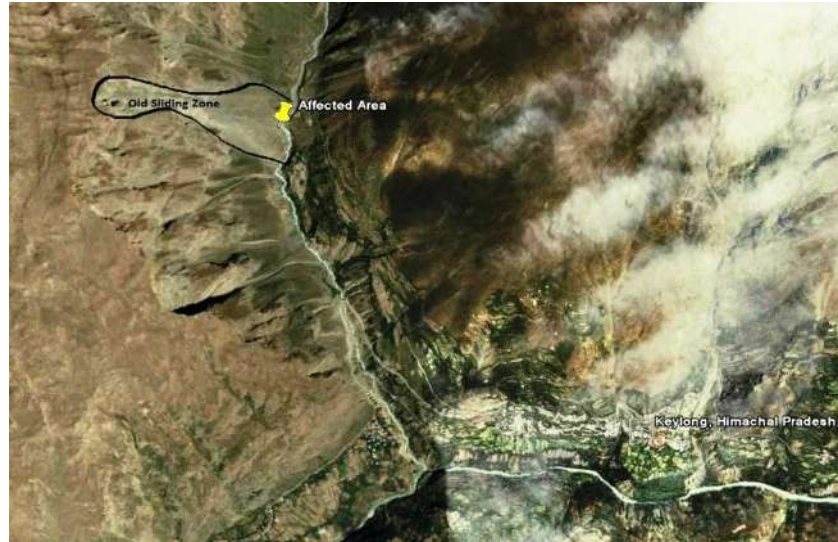
**Fig. 4**

- The satellite data further reveals that the inflow and outflow during 2013 are normal there is no effect of the slide zone on the drainage system or on the Biling Lungpa in the area.
- The post analysis using 13 June 2014 reveals the fresh activity along the old slide zone has taken place which resulted in the chocking of the river course downstream along the right bank and the accumulated water has an aerial extent of 03 hectares where as the total area of sliding zone has been calculated to be 52 hectares. (Fig. 5 & 6).

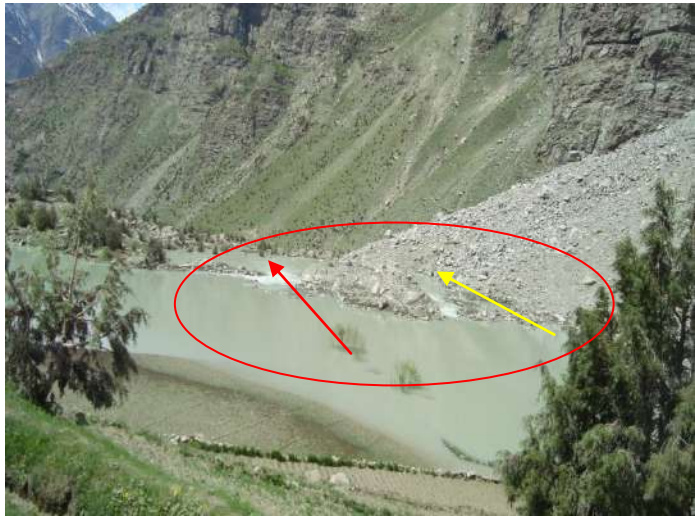
- The break in the cleavage plane leading to the failure of the rock mass which was deposited along the river course blocked the outflow.

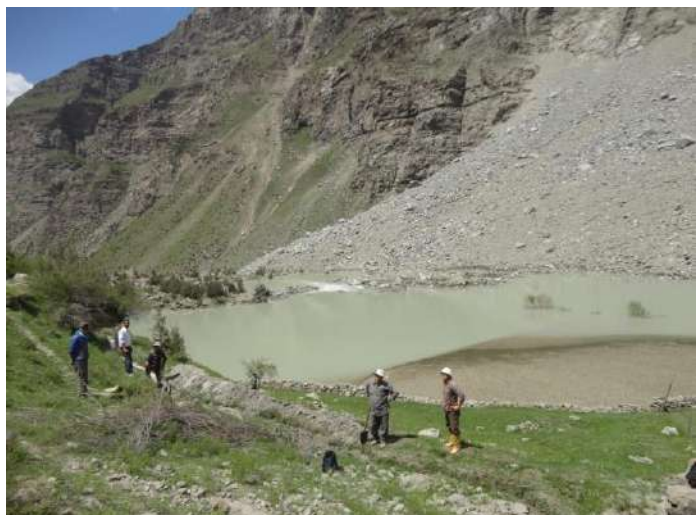
- The failure of the rock mass in such type of situations in the Higher Himalayan region is very common phenomena due to frost activity by virtue of which the rocks keep on breaking due to temperature difference and in the present case this could also be one of the reasons for the failure of the rock mass besides the failure along the joint/cleavage plan which is almost vertical in nature.
- The accumulated water has been spread all along the left bank submerging all the agriculture land available on the left bank of the Lungpa and the backward water up to footbridge level.

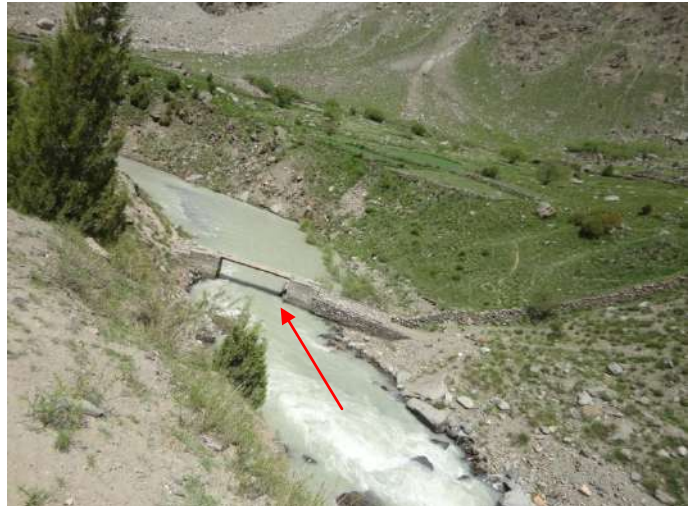
- Considering the flow conditions in the upstream side, it appears that the water column should be quite high in this part of the river course.

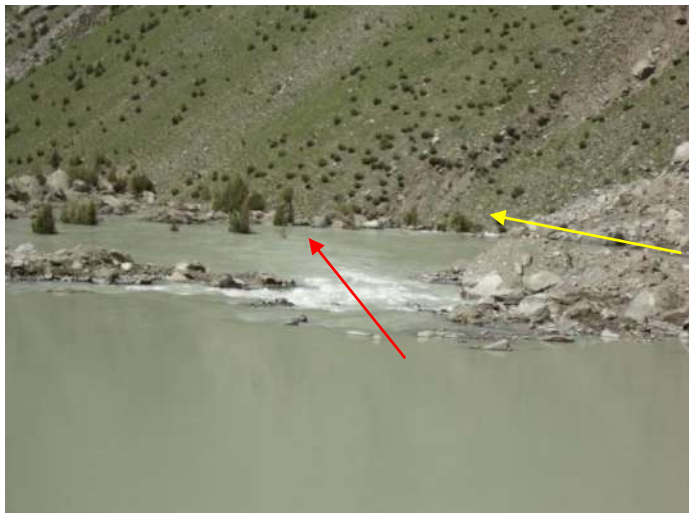
- The outflow is being regularised along the changed course of the stream now which seems to be reasonably normal on this first breach, whereas on the downstream the outflow appears to slightly slow because of the debris cover along the river course.

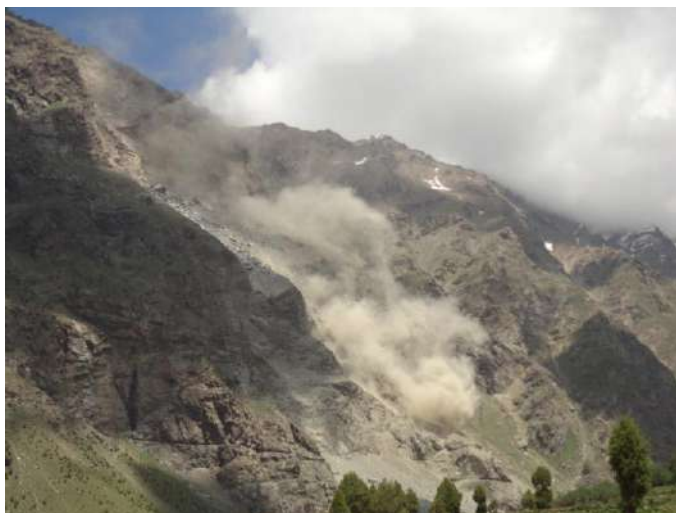
- The sliding of the material has almost reduced but not stopped completely and the chances for its continuation can't be overruled.

On the basis of the field observations and inferences made, it has been recommended that although there does not seem to be any immediate threat as on day as the outflow is almost continuous but with slower rate. Considering the thickness of the water column in the upstream side and along the depression on the left bank, it is recommended that outflow needs to be channelled more, so as to give more passage for its clearance. As the river has shifted its course now towards left side, and outflow from the first breach seems to be normal in nature but on the lower side it is relatively slow and thus needs to be accelerated by clearing its passage either using some local techniques or by using very low intensity blasting material under the supervision of some technical persons so that there is more space available for the outflow and the accumulated water gets cleared. Besides this as far as the sliding of the material is concerned, although this is a natural phenomena in the Himalayan region but still the expert comments of the Geological Survey of India(GSI) can be sought on this issue for its better management in future as this seems to be quite old one and gets activated after the gaps.
